**Flood Control Project Maintenance
Levee Inspections**

Fall 2018 Levee Maintenance Deficiency Summary Report

Yolo County Service Area 6

Waterway			Bank	Unit Miles
Unit No. 01 Right Bank of Sacramento River at Knights Landing			Right	5.87
	Spring (March - May)	Summer (June - August)	(September - November) Fall	Winter (December - February)
Unit Maintenance Rating (Fall Only)			U	
Date of Inspection	3/15/2018 - 3/15/2018		9/28/2018 - 9/28/2018	
DWR Inspector	Zach Jojola		Zach Jojola	
Accompanied By	Casey Leibler Yolo County		Casey Leibler Yolo County	
	Elisa Sabatini Yolo County		Thomas Engler MBK	
	Thomas Engler MBK

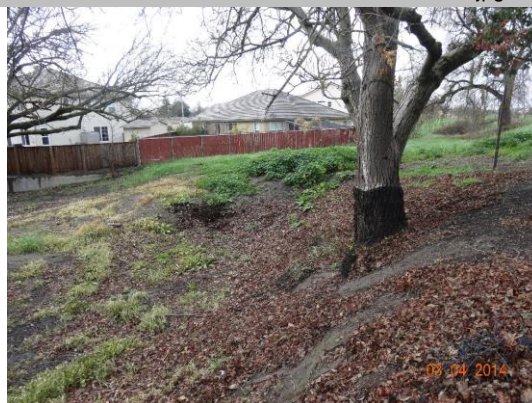
Photo 1 of 3 : UCIP_FA_2018_31903_58222.jpg

Comment Code					
Inspector Comment					
FS_ID:31903 DS_ID:19515 EP_NO: 9425 Repair Type: Non-Urgent Crossing Status: Found UCIP Comments: Need to properly abandon crossing per Title 23-- pipe has been disconnected. No signs of pipe visible on waterward and landward sides. Need to contact owner to determine additional information about pipe section through levee. FIELD_STRUCT_DESC: *ABANDONED* 8-inch steel irrigation discharge pipe through the levee, 3 feet below the crown. Pump structure in the channel. 8-inch pipe replaced by a 4-inch pipe. (Retention of an 8-inch steel pipe through the levee and a pump on a platform on the waterside [WS] authorized under Automatic Board Order (ABO) issued as Permit No. 9425, 1974 - Albert E. Nuttall). [Additional Reference(s): DWR Levee Log, 2005]. FS Date: 3/4/2014

View of landward side.

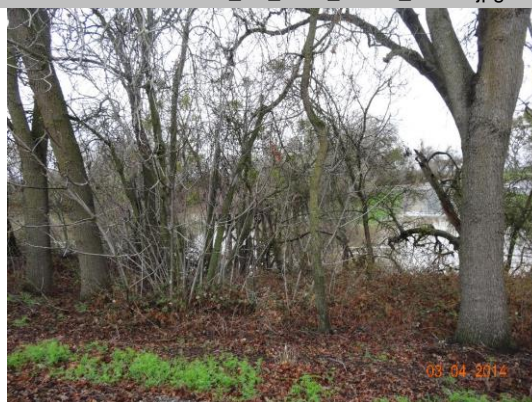
Photo 3 of 3 : UCIP_FA_2018_31903_58220.jpg

Comment Code						
Inspector Comment						
FS_ID:31903 DS_ID:19515 EP_NO: 9425 Repair Type: Non-Urgent Crossing Status: Found UCIP Comments: Need to properly abandon crossing per Title 23-- pipe has been disconnected. No signs of pipe visible on waterward and landward sides. Need to contact owner to determine additional information about pipe section through levee. FIELD_STRUCT_DESC: *ABANDONED* 8-inch steel irrigation discharge pipe through the levee, 3 feet below the crown. Pump structure in the channel. 8-inch pipe replaced by a 4-inch pipe. (Retention of an 8-inch steel pipe through the levee and a pump on a platform on the waterside [WS] authorized under Automatic Board Order (ABO) issued as Permit No. 9425, 1974 - Albert E. Nuttall). [Additional Reference(s): DWR Levee Log, 2005]. FS Date: 3/4/2014

View of waterward side.

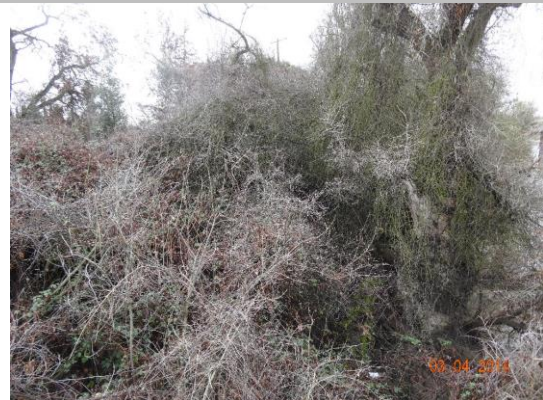
Photo 2 of 3 : UCIP_FA_2018_31904_58227.jpg

LM Start	0.21	Rating **	M	Issue No.	397
LM End	0.21	Issue Type +	En	Location *	
Category	Supplemental			GPS Latitude/Longitude	
				Start	End
Item	DWR UCIP Field Study			38.801280 °	38.801280 °
				-121.722000 °	-121.722000 °
DWR ID	19516				
Comment Code					
Inspector Comment					
FS_ID:31904 DS_ID:19516 EP_NO: N/A Repair Type: Non-Urgent Crossing Status: Indicator Found UCIP Comments: Need to properly abandon per Title 23 if corssing is no longer used--debris inside concrete box and near site. Need to contact owner. FIELD_STRUCT_DESC: 48-inch corrugated metal gravity drainage pipe through the levee, 14.5 feet below the crown. Slide gate in a concrete box on the waterside (WS) bank. (Automatic Board Order (ABO) issued as Permit No. Unknown, 1976 - Wallace) [Additional Reference(s): DWR Levee Log, 2005]. FS Date: 3/4/2014

View of waterward toe photo taken from bridge.

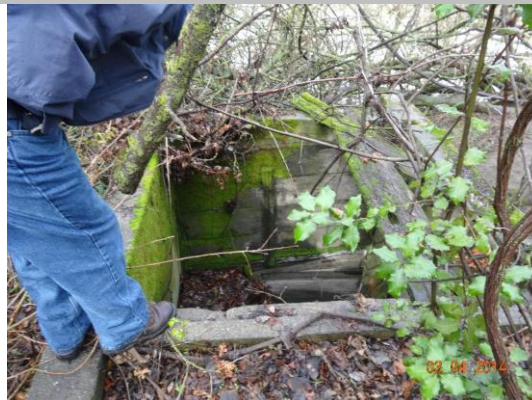
Photo 3 of 3 : UCIP_FA_2018_31904_58226.jpg

LM Start	0.21	Rating **	M	Issue No.	397 (cont)	
LM End	0.21	Issue Type +	En	Location *		
Category	Supplemental			GPS Latitude/Longitude		
				Start	End	
Item	DWR UCIP Field Study			38.801280 °	38.801280 °	
				-121.722000 °	-121.722000 °	
DWR ID	19516					
Comment Code						
Inspector Comment						
FS_ID:31904 DS_ID:19516 EP_NO: N/A Repair Type: Non-Urgent Crossing Status: Indicator Found UCIP Comments: Need to properly abandon per Title 23 if corssing is no longer used--debris inside concrete box and near site. Need to contact owner. FIELD_STRUCT_DESC: 48-inch corrugated metal gravity drainage pipe through the levee, 14.5 feet below the crown. Slide gate in a concrete box on the waterside (WS) bank. (Automatic Board Order (ABO) issued as Permit No. Unknown, 1976 - Wallace) [Additional Reference(s): DWR Levee Log, 2005]. FS Date: 3/4/2014

Concrete box located on waterward side.

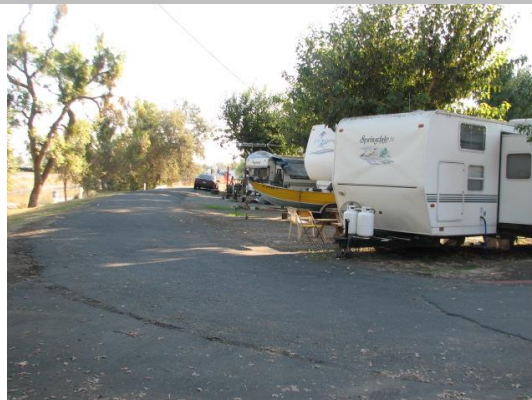
Photo 1 of 2 : FA_2018_NA0022_350_28_20180904_00015.jpg

LM Start	0.22	Rating **	M	Issue No.	28
LM End	0.25	Issue Type +	En	Location *	LS
Category	Earthen Levee			GPS Latitude/Longitude	
				Start	End
Item	Encroachments			38.801394 °	38.801613 °
				-121.721918 °	-121.721328 °
DWR ID	DWR_NA0022_01_s_2012_28				
Comment Code					
BU : Building					
Inspector Comment					
RV park runs on and along levee to bridge.

The RV park is encroached into the levee crown. Fall 2013

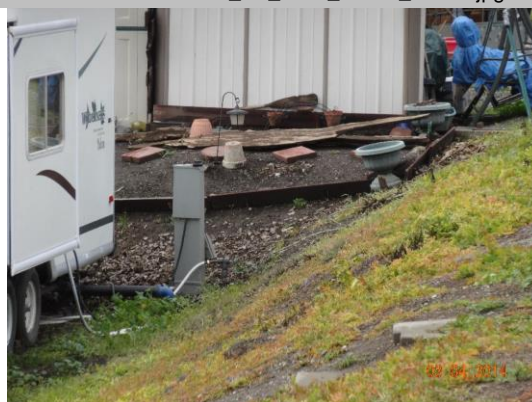
Photo 2 of 3 : UCIP_FA_2018_45403_60804.jpg

Comment Code						
Inspector Comment						
FS_ID:45403 DS_ID:19513 EP_NO: 9424 Repair Type: Non-Urgent Crossing Status: Indicator Found UCIP Comments: Unable to determine alignment of crossing--it's either through levee or along landward side. It appears that the waterline goes along landward side. Need to contact owner to obtain additional information about crossing. 2 inch metal pipe sticking out at the waterward berm edge. FIELD_STRUCT_DESC: Water pipe of an unknown size or material through the levee, at an unknown depth. Faucets on the landside (LS) slope. (Retention of an underground water pipe and faucet on the LS slope authorized under Automatic Board Order (ABO) issued as Permit No. 9424, 1974 - O. H. Ivey). [Additional Reference(s): DWR Levee Log, 2005]. FS Date: 3/4/2014

Spigot located on landward toe.

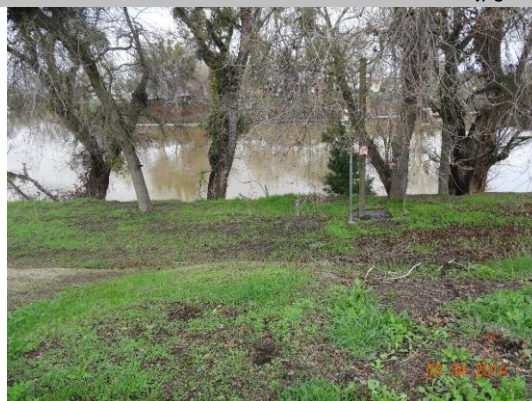
Photo 3 of 3 : UCIP_FA_2018_45403_60803.jpg

Comment Code						
Inspector Comment						
FS_ID:45403 DS_ID:19513 EP_NO: 9424 Repair Type: Non-Urgent Crossing Status: Indicator Found UCIP Comments: Unable to determine alignment of crossing--it's either through levee or along landward side. It appears that the waterline goes along landward side. Need to contact owner to obtain additional information about crossing. 2 inch metal pipe sticking out at the waterward berm edge. FIELD_STRUCT_DESC: Water pipe of an unknown size or material through the levee, at an unknown depth. Faucets on the landside (LS) slope. (Retention of an underground water pipe and faucet on the LS slope authorized under Automatic Board Order (ABO) issued as Permit No. 9424, 1974 - O. H. Ivey). [Additional Reference(s): DWR Levee Log, 2005]. FS Date: 3/4/2014

View of waterward side.

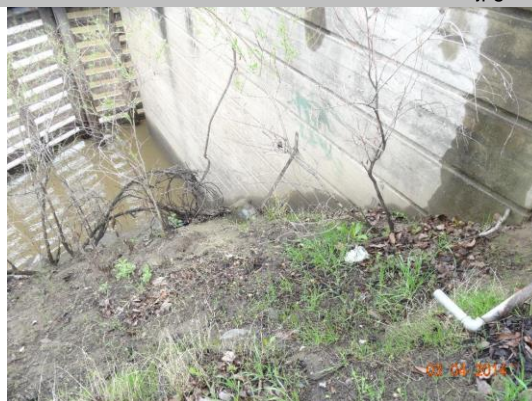
Photo 1 of 2 : UCIP_FA_2018_31906_58238.jpg

Comment Code					
Inspector Comment					
FS_ID:31906 DS_ID:19534 EP_NO: 17016 Repair Type: Non-Urgent Crossing Status: Indicator Found UCIP Comments: Unable to confirm crossing alignment--steel pipe visible on waterward side however, unable to confirm if crossing is the same one found during field confirmation. Need to contact owner to verify alignment and status of crossing. Slope was too steep to verify and obtain additional information about pipe. FIELD_STRUCT_DESC: Three 2-inch and three 1.5-inch fiber optics conduits through the levee, encased in a single high-density polyethylene (HDPE) casing, 30 feet below the crown. Concrete cap on each end of the HDPE casing. Voids in the HDPE casing grouted. (Plans to install three 2-inch and three 1.5-inch fiber optics conduits within a casing across and bored under the Sacramento River and its levees authorized under Permit No. 17016, 2000 - Worldwide Fiber). FS Date: 3/4/2014

Steel pipe located on waterward side--pipe disconnected.

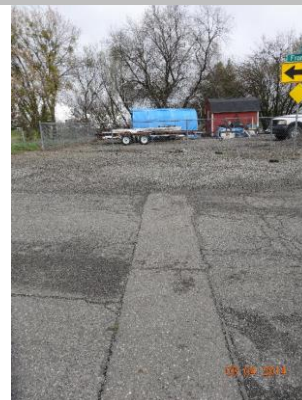
Photo 2 of 3 : UCIP_FA_2018_31627_57880.jpg

LM Start	0.51	Rating **	M	Issue No.	400
LM End	0.51	Issue Type +	En	Location *	
Category	Supplemental			GPS Latitude/Longitude	
				Start	End
Item	DWR UCIP Field Study			38.802062°	38.802062°
				-121.716740°	-121.716740°
DWR ID	19544				
Comment Code					
Inspector Comment					
FS_ID:31627 DS_ID:19544 EP_NO: N/A Repair Type: Non-Urgent Crossing Status: Indicator Found UCIP Comments: Unable to confirm if signs of crossing are for the same crossing listed here. Need to contact owner and determine additional information about crossing. Also found is service box for water line--need permit and alignment confirmation. FIELD_STRUCT_DESC: 10-inch steel pipe of an unknown purpose through the levee, at an unknown depth. [Additional Reference(s): DWR Levee Log, 2005. USACE Sacramento O&M Manual 127, June 1953, (Station 285+27)]. FS Date: 3/4/2014

View of waterward side. Alignment is visible on paved road.

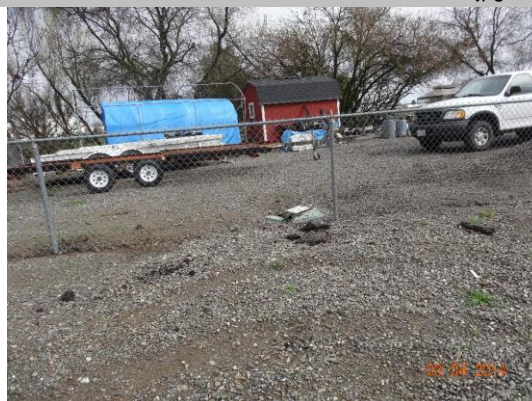
Photo 3 of 3 : UCIP_FA_2018_31627_57879.jpg

LM Start	0.51	Rating **	M	Issue No.	400 (cont)	
LM End	0.51	Issue Type +	En	Location *		
Category	Supplemental			GPS Latitude/Longitude		
				Start		End
Item	DWR UCIP Field Study			38.802062 °		38.802062 °
				-121.716740 °		-121.716740 °
DWR ID	19544					
Comment Code						
Inspector Comment						
FS_ID:31627 DS_ID:19544 EP_NO: N/A Repair Type: Non-Urgent Crossing Status: Indicator Found UCIP Comments: Unable to confirm if signs of crossing are for the same crossing listed here. Need to contact owner and determine additional information about crossing. Also found is service box for water line--need permit and alignment confirmation. FIELD_STRUCT_DESC: 10-inch steel pipe of an unknown purpose through the levee, at an unknown depth. [Additional Reference(s): DWR Levee Log, 2005. USACE Sacramento O&M Manual 127, June 1953, (Station 285+27)]. FS Date: 3/4/2014

Service box located on waterward side near fence post.

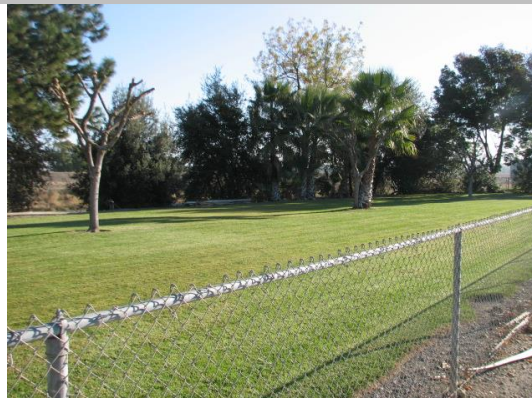
Photo 1 of 1 : FA_2018_NA0022_350_24_20180904_00013.jpg

LM Start	0.52	Rating **	U	Issue No.	63
LM End	0.53	Issue Type +	En	Location *	LS
Category	Earthen Levee			GPS Latitude/Longitude	
				Start	End
Item	Encroachments			38.801980 °	38.801929 °
				-121.716502 °	-121.716330 °
DWR ID	DWR_NA0022_01_f_2017_63				
Comment Code					
FE : Fence					
Inspector Comment

View of chain link fence on crown. Fall 2013.

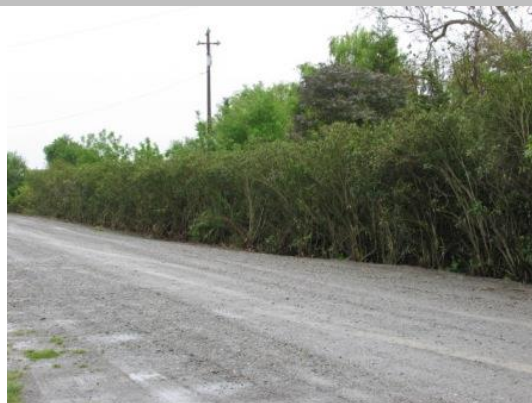
Photo 1 of 1 : FA_2018_NA0022_350_22_20180904_00011.jpg

Oleanders along the shoulder.

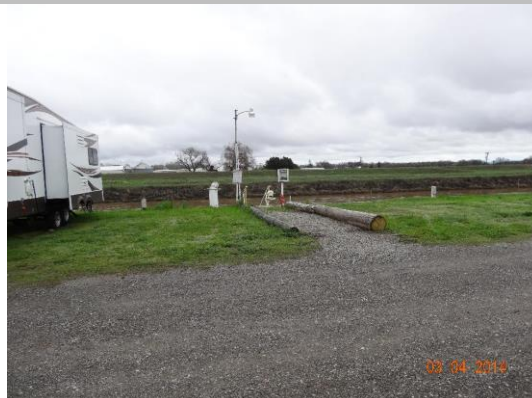
Photo 1 of 3 : UCIP_FA_2018_38188_69562.jpg

Comment Code						
Inspector Comment						
FS_ID:38188 DS_ID:19519 EP_NO: N/A Repair Type: Non-Urgent Crossing Status: Indicator Found UCIP Comments: Unable to find any signs of crossing on waterward side. Signs of concrete riser visible on landward side. If crossing is abandoned owner will need to coordinate with the Central Valley Flood Protection Board (CVFPB) for Title 23 requirements. FIELD_STRUCT_DESC: 10-inch pipe of an unknown material or purpose through the levee, 3.3 feet below the crown. 24-inch concrete riser on the landside (LS). Plate welded on the waterside (WS) end in 1975. [Additional Reference(s): DWR Levee Log, 2005]. FS Date: 3/4/2014

View of waterward side.

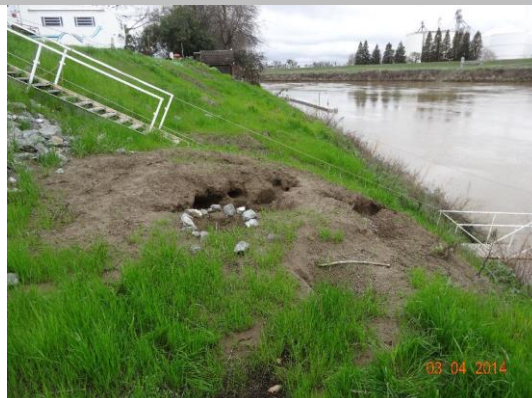
Photo 2 of 3 : UCIP_FA_2018_38188_69560.jpg

View of waterward slope. Large hole visible on waterward side.

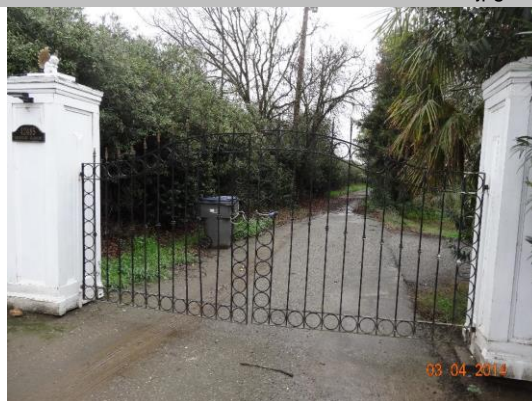
Photo 3 of 3 : UCIP_FA_2018_38188_69561.jpg

Comment Code						
Inspector Comment						
FS_ID:38188						
DS_ID:19519						
EP_NO: N/A						
Repair Type: Non-Urgent						
Crossing Status: Indicator Found						
UCIP Comments: Unable to find any signs of crossing on waterward side. Signs of concrete riser visible on landward side. If crossing is abandoned owner will need to coordinate with the Central Valley Flood Protection Board (CVFPB) for Title 23 requirements.						
FIELD_STRUCT_DESC: 10-inch pipe of an unknown material or purpose through the levee, 3.3 feet below the crown. 24-inch concrete riser on the landside (LS). Plate welded on the waterside (WS) end in 1975. [Additional Reference(s): DWR Levee Log, 2005].						
FS Date: 3/4/2014

Residential property standpipe located behind fence.

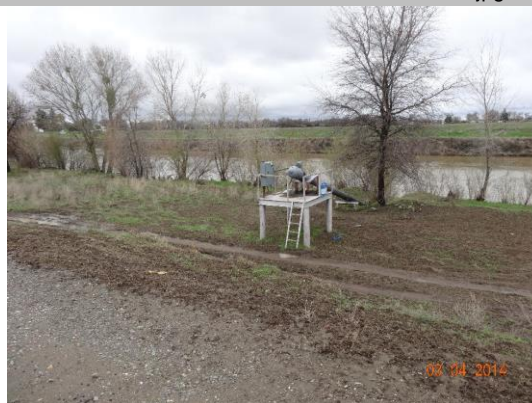
Photo 1 of 3 : UCIP_FA_2018_31969_58410.jpg

Comment Code						
Inspector Comment						
FS_ID:31969 DS_ID:19540 EP_NO: N/A Repair Type: Non-Urgent Crossing Status: Found UCIP Comments: Pipe section on waterward side appears to have been removed and reinstalled--Need to contact owner to obtain additional information regarding work completed. FIELD_STRUCT_DESC: 14-inch steel irrigation discharge pipe through the levee, 4.6 feet below the crown. Pump and valve on the riverbank. See DS_ID 19521. (Plans for installation of an angle mount low-lift pump and structure to replace an existing portable pumping plant, which will be connected to the existing 14-inch discharge pipe through the levee authorized under Permit No. 3798, 1961 - Alta Morris). [Additional Reference(s): USACE Sacramento O&M Manual 127, June 1953, (Station 266+72.2)]. FS Date: 3/4/2014

View of waterward side.

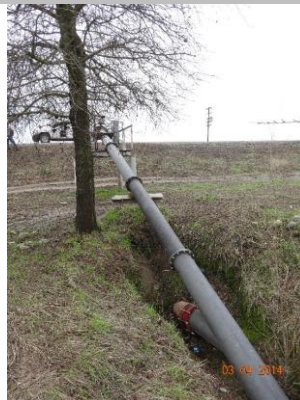
Photo 2 of 3 : UCIP_FA_2018_31969_58409.jpg

Comment Code						
Inspector Comment						
FS_ID:31969 DS_ID:19540 EP_NO: N/A Repair Type: Non-Urgent Crossing Status: Found UCIP Comments: Pipe section on waterward side appears to have been removed and reinstalled--Need to contact owner to obtain additional information regarding work completed. FIELD_STRUCT_DESC: 14-inch steel irrigation discharge pipe through the levee, 4.6 feet below the crown. Pump and valve on the riverbank. See DS_ID 19521. (Plans for installation of an angle mount low-lift pump and structure to replace an existing portable pumping plant, which will be connected to the existing 14-inch discharge pipe through the levee authorized under Permit No. 3798, 1961 - Alta Morris). [Additional Reference(s): USACE Sacramento O&M Manual 127, June 1953, (Station 266+72.2)]. FS Date: 3/4/2014

Pipe located on waterward side.

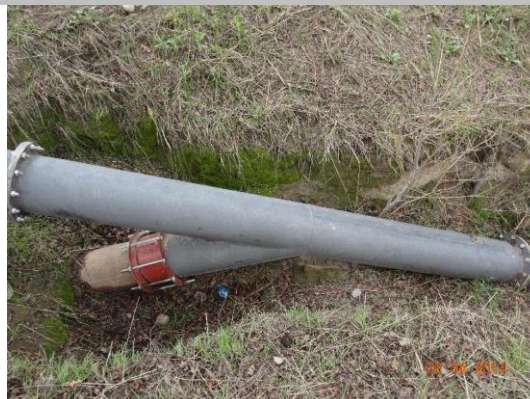
Photo 3 of 3 : UCIP_FA_2018_31969_58408.jpg

Pipe junction exposed on waterward side.

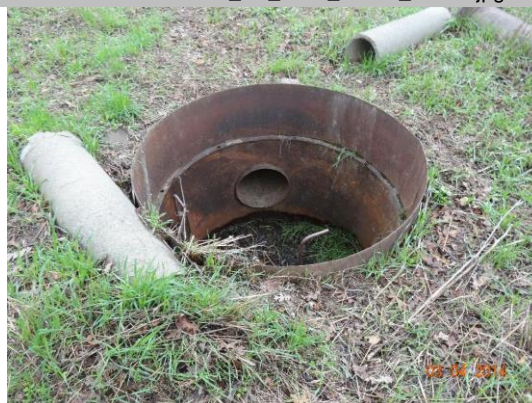
Photo 2 of 3 : UCIP_FA_2018_31912_58260.jpg

Comment Code						
Inspector Comment						
FS_ID:31912 DS_ID:19522 EP_NO: 6296 Repair Type: Non-Urgent Crossing Status: Found UCIP Comments: Siphon breaker housing on landward slope unit damaged and debris scattered on landward side. Unable to determine if crossing is still in use. Need to contact owner to determine status of crossing. FIELD_STRUCT_DESC: 12-inch (not 14-inch as indicated in the desk study) coated steel irrigation discharge pipe through the levee, 11.8 feet below the crown. Standard corrugated metal cutoff wall around pipe at centerline of levee. 1.25-inch electrical conduit through the levee. Electrical control panel on the waterside (WS) slope. Slant pump mounted on a steel structure on the riverbank. Siphon breaker on the landside (LS) shoulder. Pipe extends from pump to existing irrigation ditch at the LS toe. (Plans to install a pump and pipe through the levee authorized under Permit No. 6296, 1968 - Emma Collier). [Additional Reference(s): DWR Levee Log, 2005]. FS Date: 3/4/2014

Riser on landward toe.

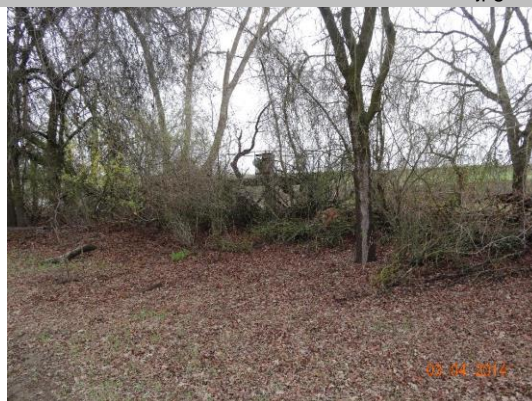
Photo 3 of 3 : UCIP_FA_2018_31912_58259.jpg

Comment Code						
Inspector Comment						
FS_ID:31912 DS_ID:19522 EP_NO: 6296 Repair Type: Non-Urgent Crossing Status: Found UCIP Comments: Siphon breaker housing on landward slope unit damaged and debris scattered on landward side. Unable to determine if crossing is still in use. Need to contact owner to determine status of crossing. FIELD_STRUCT_DESC: 12-inch (not 14-inch as indicated in the desk study) coated steel irrigation discharge pipe through the levee, 11.8 feet below the crown. Standard corrugated metal cutoff wall around pipe at centerline of levee. 1.25-inch electrical conduit through the levee. Electrical control panel on the waterside (WS) slope. Slant pump mounted on a steel structure on the riverbank. Siphon breaker on the landside (LS) shoulder. Pipe extends from pump to existing irrigation ditch at the LS toe. (Plans to install a pump and pipe through the levee authorized under Permit No. 6296, 1968 - Emma Collier). [Additional Reference(s): DWR Levee Log, 2005]. FS Date: 3/4/2014

View of waterward side.

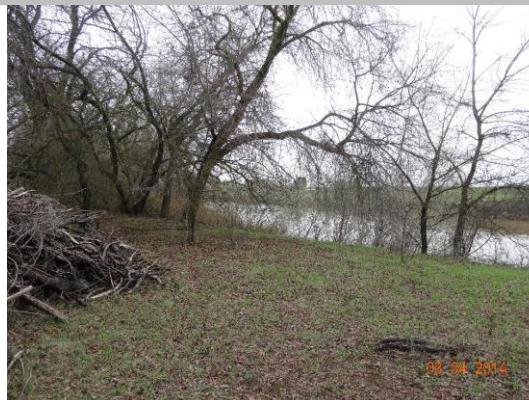
Photo 2 of 3 : UCIP_FA_2018_38190_69565.jpg

View of waterward side.

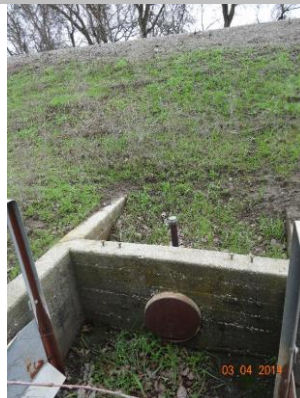
Photo 3 of 3 : UCIP_FA_2018_38190_69564.jpg

Concrete box located on landward toe.

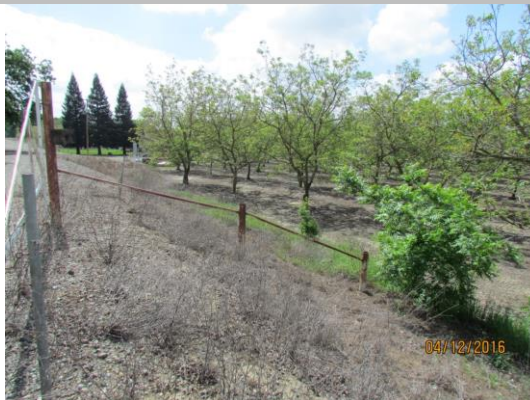
Photo 1 of 1 : FA_2018_NA0022_350_112_20180904_00053.jpg

View of the tree at the toe of the levee on the landward side looking downstream. Spring 2016.

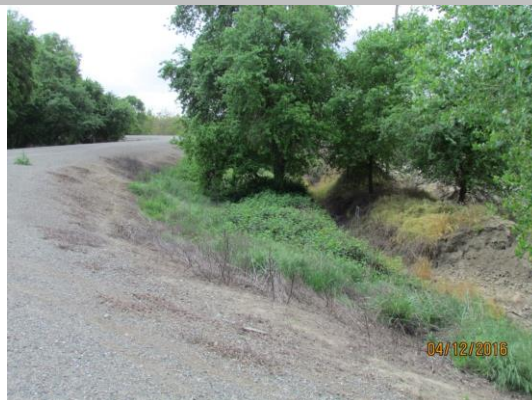
Photo 1 of 1 : FA_2018_NA0022_350_7_20180904_00003.jpg

View of the ditch at the levee toe on the landward side looking downstream. Spring 2016.

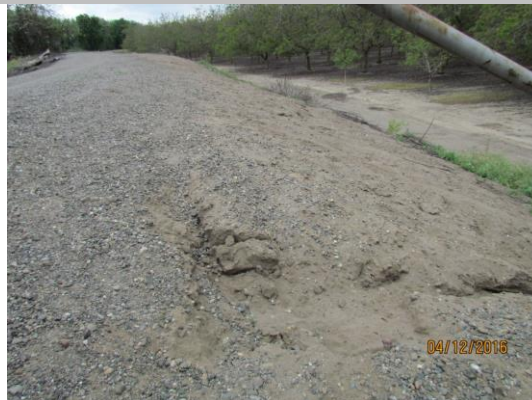
Photo 1 of 2 : FA_2018_NA0022_350_35_20180904_00017.jpg

Perspective view of the erosion on the landward side of the levee. Spring 2016.

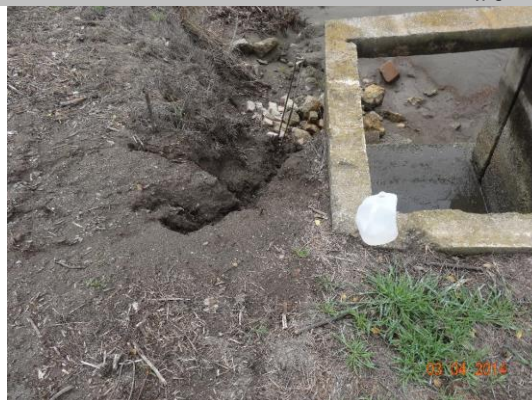
Photo 2 of 3 : UCIP_FA_2018_52726_57914.jpg

Slope erosion near concrete box.

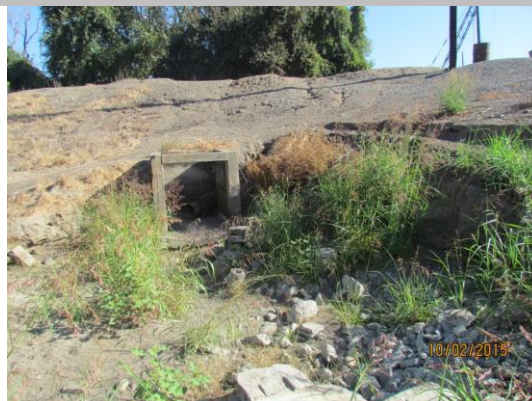
Photo 3 of 4 : FA_2018_NA0022_350_96_20180904_00049.jpg

The erosion is within the levee prism. Fall 2015.

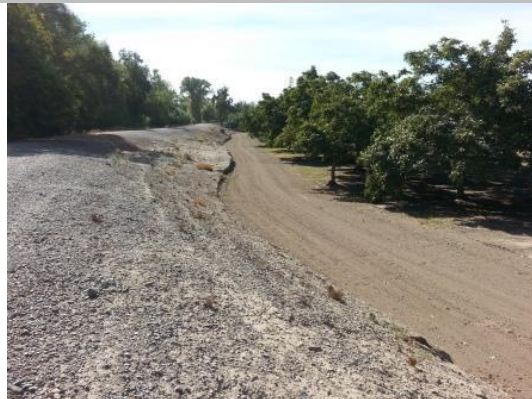
Photo 1 of 2 : FA_2018_NA0022_350_94_20180904_00045.jpg

An updated view of the site where landside slope was tilled due to agricultural activity. Fall inspection 10/07/2016.

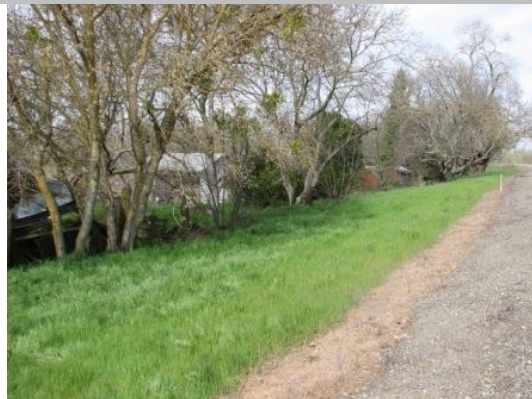
Photo 2 of 2 : FA_2018_NA0022_350_12_20180904_00008.jpg

The buildings are encroaching into the levee slope.

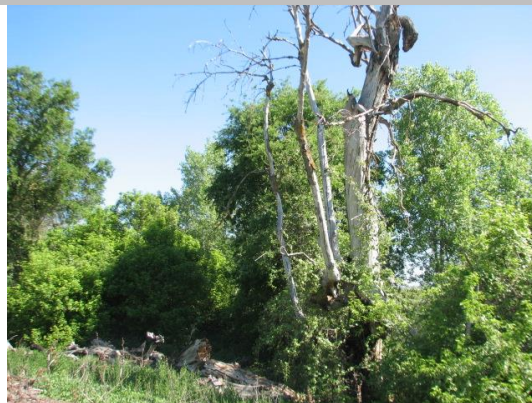
Photo 2 of 2 : FA_2018_NA0022_350_47_20180904_00026.jpg

Some trees have fallen and others are dying and need to be monitored. The trees may pose a threat to the levee. Spring 2014

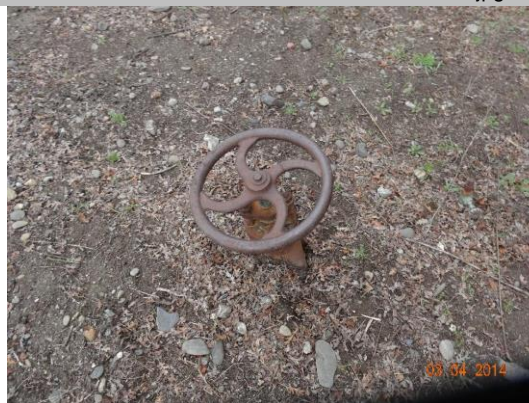
Photo 2 of 3 : UCIP_FA_2018_39858_71840.jpg

Positive closure device is buried on waterward side.

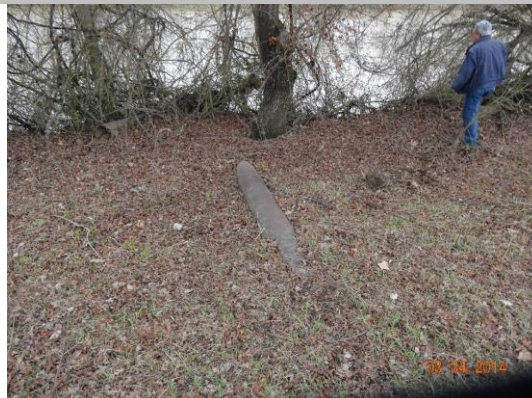
Photo 3 of 3 : UCIP_FA_2018_39858_71845.jpg

Pipe section visible on waterward side.

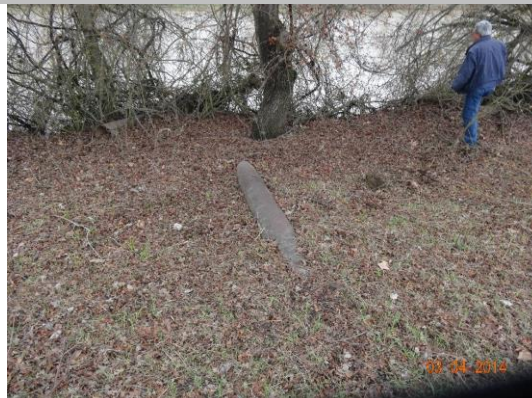
Photo 3 of 3 : UCIP_FA_2018_31916_58273.jpg

Pipe section visible on waterward side.

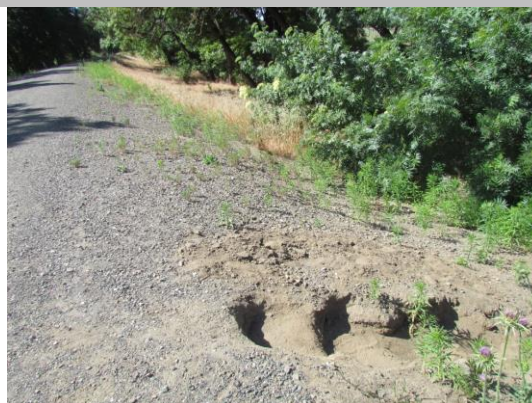
Photo 1 of 3 : FA_2018_NA0022_350_79_20180904_00035.jpg

View of the stairs on the landward side of the levee looking downstream. Spring 2015.

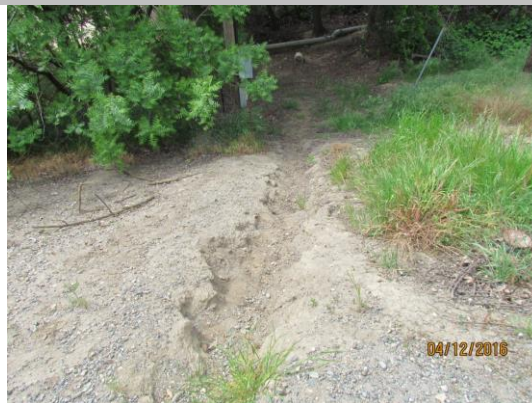
Photo 2 of 3 : FA_2018_NA0022_350_79_20180904_00036.jpg

Dirt stairs has eroded and caused a slope stability. Spring 2016.

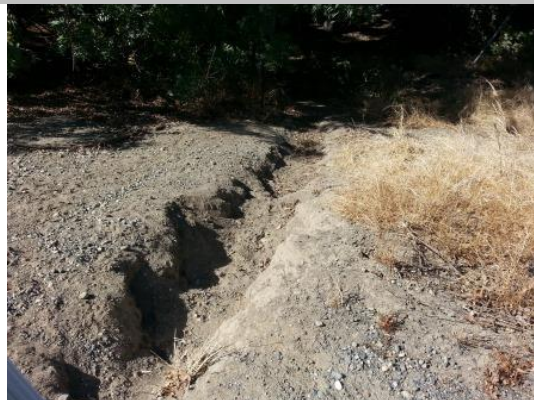
Photo 3 of 3 : FA_2018_NA0022_350_79_20180904_00037.jpg

Stairwell has eroded more creating erosion issue. Fall inspection 10/07/2016.

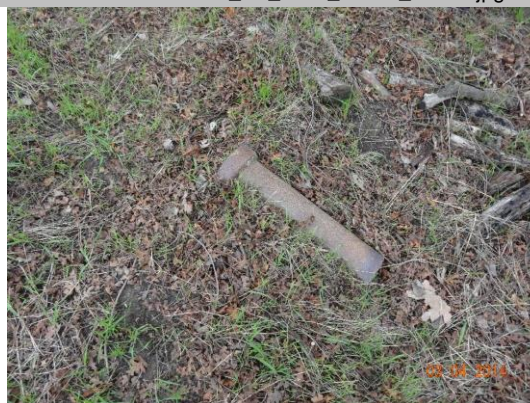
Photo 2 of 3 : UCIP_FA_2018_38996_69567.jpg

Debris scattered on landward side.

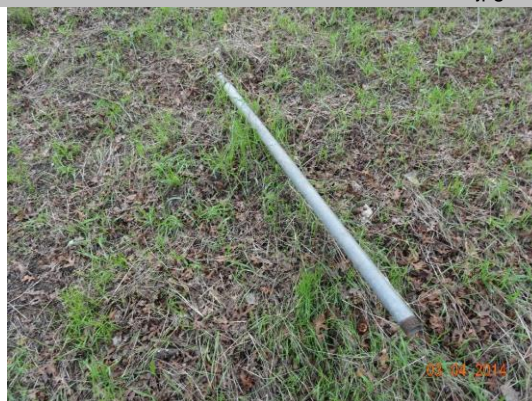
Photo 3 of 3 : UCIP_FA_2018_38996_69566.jpg

Abandoned conduit line through levee.

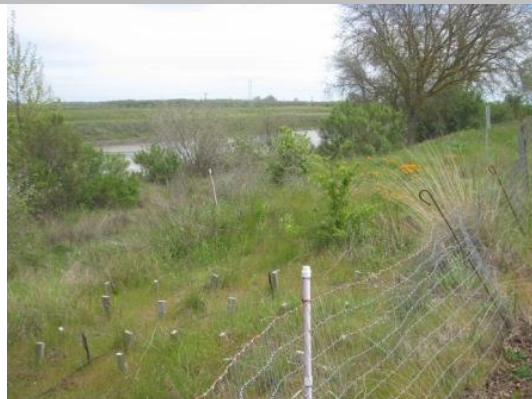
Photo 2 of 2 : FA_2018_NA0022_350_36_20180904_00020.jpg

Fence, irrigation and stakes in the revegetation site.

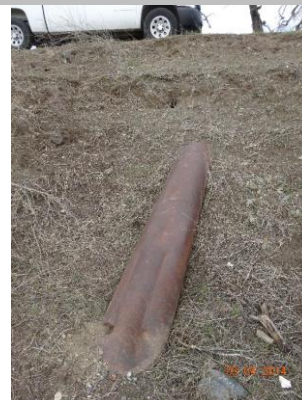
Photo 2 of 3 : UCIP_FA_2018_31986_58439.jpg

Pipe through levee punctured visible on landward slope.

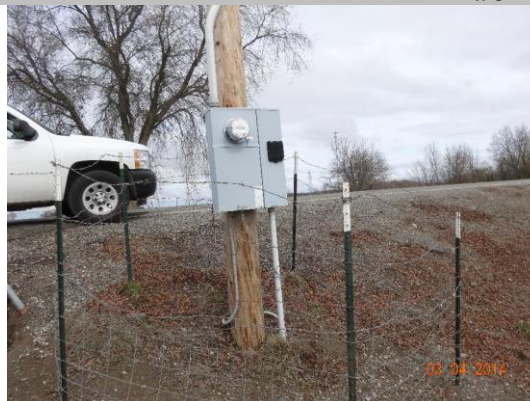
Photo 2 of 3 : UCIP_FA_2018_52728_69572.jpg

Power pole with conduit line through levee.

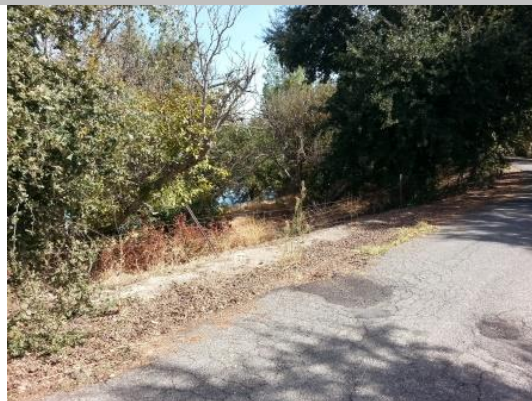
Photo 1 of 1 : FA_2018_NA0022_350_145_20180904_00062.jpg

Fence on WS slope near levee crown. Fall inspection 10/07/2016.

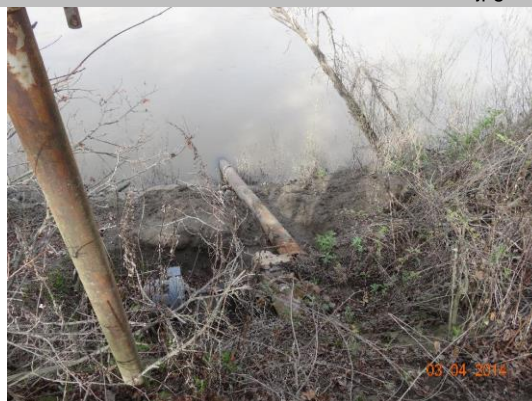
Photo 3 of 3 : UCIP_FA_2018_31927_58335.jpg

Pipe visible on waterward toe.

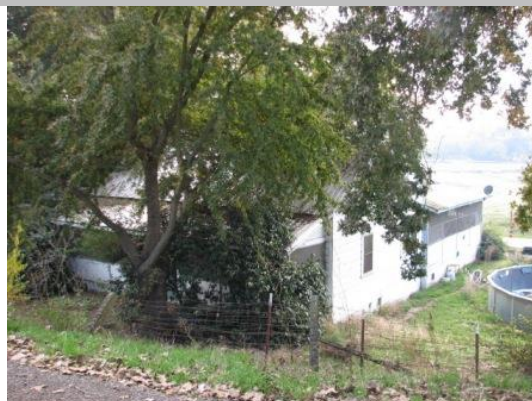
Photo 1 of 1 : FA_2018_NA0022_350_1_20180904_00001.jpg

The house and landscape are in the easment of the levee. Fall 2011

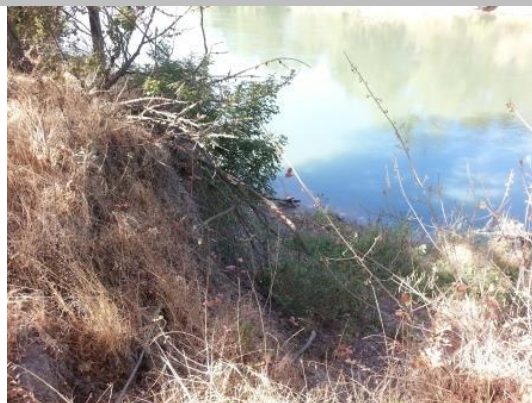
Photo 1 of 3 : FA_2018_NA0022_350_84_20180904_00041.jpg

View of an erosion site on waterward slope. Fall inspection 10/07/2016.

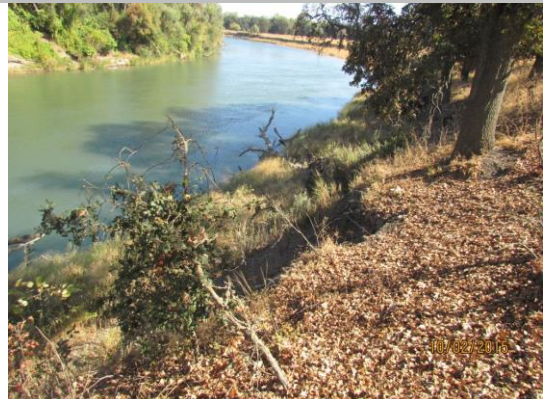
Photo 3 of 3 : FA_2018_NA0022_350_84_20180904_00043.jpg

View of the erosion on the waterward side of the levee looking
downstream. Fall 2015.
